Yukon Placer Database Operations Report

Field Name: Ahnert, 1980-2004

Stream: 24 Pup: a tributary of Hunker

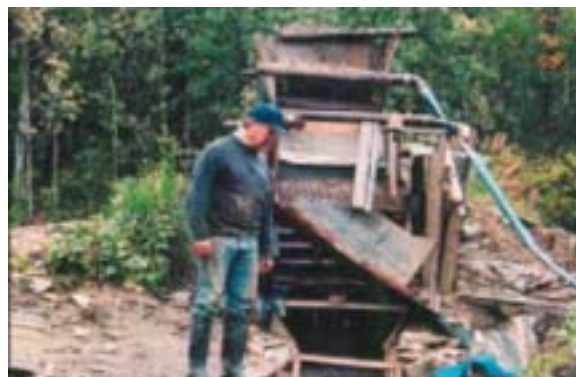
Title: Gerald Ahnert

Gerald and Elizabeth Ahnert's operation on 24 Pup, Hunker Creek.
