# Yukon Placer Database Operations Report

**Field Name:** Nicholson, 1974-77, 1980-84, 1989-2003

**Stream:** Lovett Gulch: a tributary of Bonanza

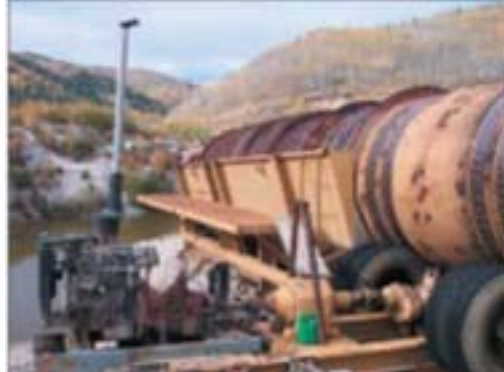
**Title:** Clive Nicholson operation, 1998-2002, Bonanza Cree

Large trommel and dump box used by Clive Nicholson, set up among White Channel gravel tailings, near Lovett Gulch on Bonanza Creek.

1998-2003 - A Caterpillar D9 bulldozer was used to strip overburden and excavate pay gravel. Two Caterpillar 627 belly scrapers were used to strip and stack overburden and waste gravel. One Caterpillar 920 loader was used to feed the wash plant. A large steel trommel, 7 feet in diameter by 40 feet long, fed a single sluice run, 4 feet wide by 30 feet long, with expanded metal riffles over Nomad matting. A 5-inch by 6-inch Paramount water pump, powered by a Caterpillar 3304 diesel engine, provided 800 or 900 igpm which was used to sluice up to 100 cubic yards per hour, which was reduced to 60 cubic yards per hour in 2002. Water was recycled out-of-stream, within two abandoned mining cuts which filled with seepage water.
