Yukon Placer Database Operations Report

Field Name: Connelly, 1998-2002

Stream: Vancouver: a tributary of McQuesten

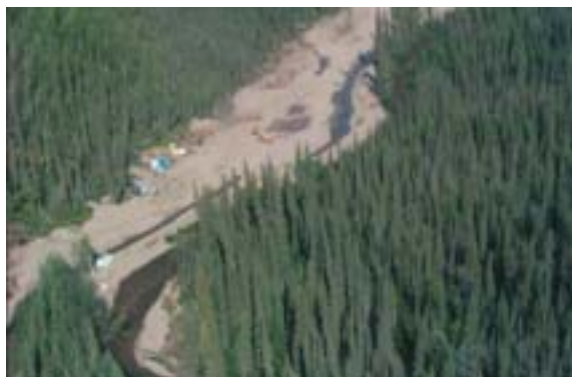
Title: Connelly's operation on Vancouver Creek, 1998-2002

A Caterpillar 235 excavator was used for processing pay gravels and a Caterpillar D-8 bulldozer was used for stripping and placement of waste. A vibrating screen deck with a single sluice run measuring 32 feet long by 4 feet wide has been used for the four years of mining. Vancouver Creek supplied the wash plant as required, which fed through the drain created by previous mining cuts to the settling ponds located out-of-stream at the lowest point of mining work by Don Connelly.
