Yukon Placer Database Operations Report

Field Name: Kissler/Jackson, 1999-2003

Stream: 7 Pup: a tributary of Victoria Gulch

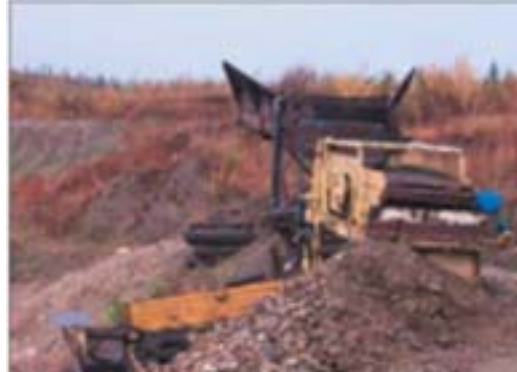
Title: Kissler on 7 Pup; 2002

Close up view of the dump box, shaker plant and sluice runs used by Everett Kissler on 7 Pup, a left limit tributary to Victoria Gulch on Upper Bonanza Creek.

A Caterpillar 966 loader was used to dig pay gravel, feed the wash plant and remove tailings. A shaking screen deck about 10 feet by 10 feet was followed by a single sluice run, 2 feet wide by 21 feet long, with expanded metal riffles over Nomad mat. A Gorman-Rupp 4 inch water pump supplied about 400 igpm of water which was used to sluice about 25 cubic yards per hour. Surface runoff was minimal this high up on hill side but seepage water was recycle in two settling ponds about 50 feet by 50 feet each. Kissler sluiced with total recycle and no discharge in 2002. During 2003, this was an out of stream operation capturing ground water and rainfall in reservoir ponds.
