Yukon Placer Database Operations Report

Field Name: Gyppo Mining Ltd./Abermeth, 1992-2000

Stream: Unnamed: a tributary of Dominion

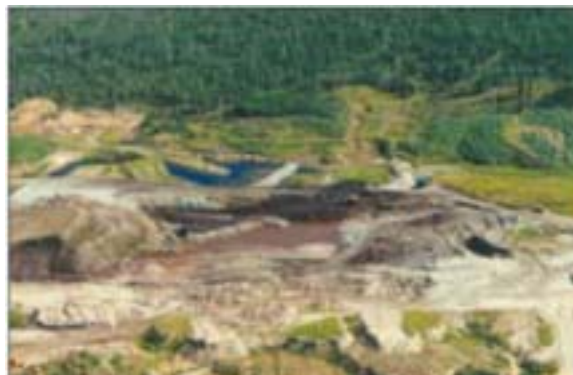
Title: Gyppo Mining Ltd., Unnamed Tributary of Dominion

George Abermeth's mine site in 1998. The creek flows along the right limit edge of the valley to back of the photo.
