Yukon Placer Database Operations Report

Field Name: Nafziger, 1989-2003

Stream: Little Blanche: a tributary of Quartz

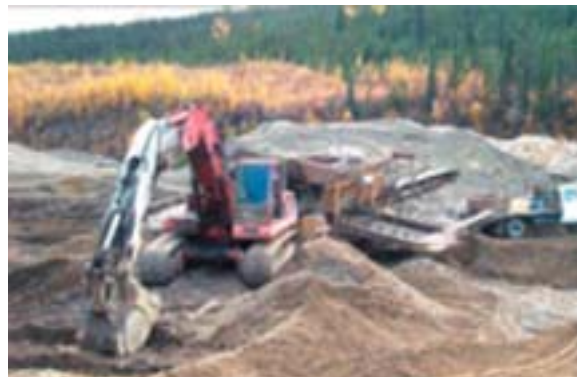
Title: Nafziger's sluice plant on Little Blanche Creek

In 1995, two Caterpillar D8 bulldozers were used to strip overburden, excavate and push gravel as to remove and spread tailings. A backhoe excavator was used to feed the wash plant. A 10-foot by 10-foot hopper with a grizzly fed a Super Sluice IV screen deck followed by 2 sluice runs 3 feet wide by 6 feet long, lined with angle iron riffles. This was followed by 4 feet of slick plate leading to 2 more sluice runs 4 feet by 12 feet, lined with expanded metal over Nomad matting. An 8-inch pump, powered by a GM 371 diesel engine, delivered approximately 1500 igpm of water, which was used to process about 85 cubic yards per hour. Water was sorted in an instream reservoir on Little Blanche Creek and was recycled from settling ponds in old mining cuts.
