Yukon Placer Database Operations Report

Field Name: Daunt, 1983-94, 1998-2003

Stream: Skookum Gulch: a tributary of Bonanza

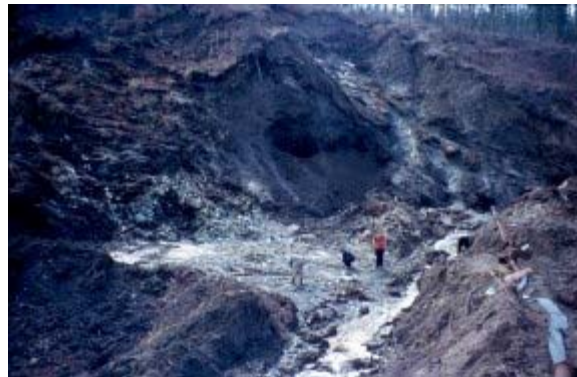
Title: Daunt's Operation on Skookum Gulch; 2000
