Yukon Placer Database Operations Report

Field Name: Barchen, 2001-2004

Stream: Owl: a tributary of Mayo Lake

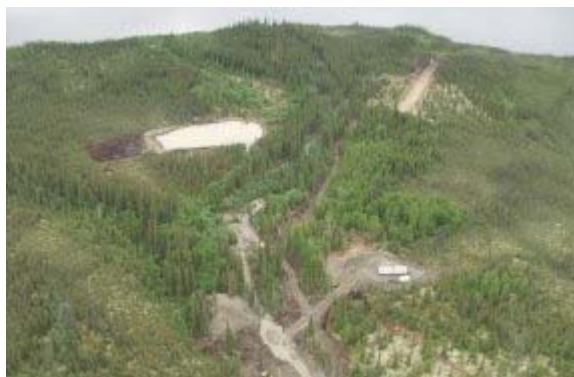
Title: Aerial View of Barchen's Operation; 2003

2003 - Mine site preparation (stripping, drains and settling pond construction) was the bulk of work until July. The mine cut progressed upstream in the steep valley walls of Owl Creek. The main channel was mined while the stream was temporarily diverted to the left limit of the valley and perched above the mine cut.

In 2003 settling ponds and drain were established on the right limit of Owl Creek downstream of the alluvial fan apex. Settling facilities were located well out of stream as per licence with no discharge.
