Yukon Placer Database Operations Report

Field Name: Roberts & White, 1996-2003

Stream: Gauvin Gulch: a tributary of Upper Bonanza

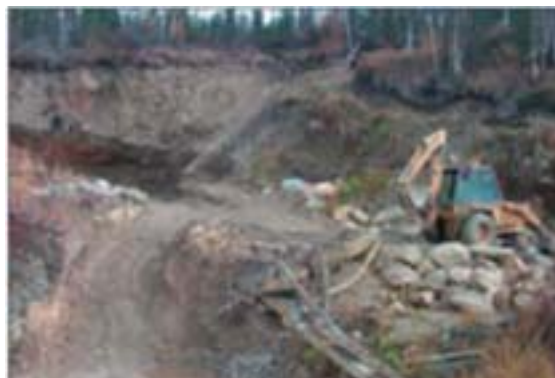
Title: Roberts & White, '98-'02, Gauvin Gulch

Lookin at the mining cut on the left limit of upper Gauvin Gulch where W.L. Roberts used this small back hoe/loader to feed the wash plant in the foreground. Several large boulders removed from the pay zone can be seen near the wash plant.
