Yukon Placer Database Operations Report

Field Name: Johnson, 1993-2002

Stream: Burwash: a tributary of Kluane River

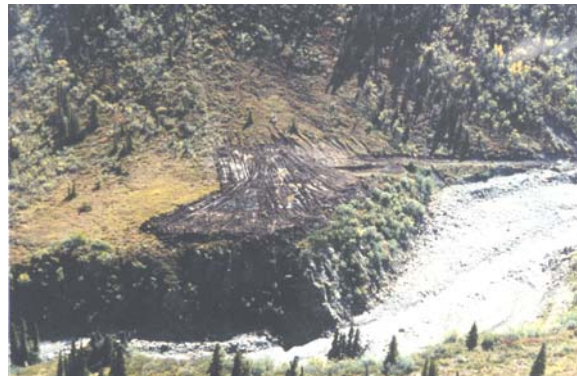
Title: Johnson Operation on Burwash Creek.
