# Yukon Placer Database Operations Report

**Field Name:** Tatlow Placer Mines Ltd./Quartz Creek Placers,  
1991-2003

**Stream:** Quartz: a tributary of Indian

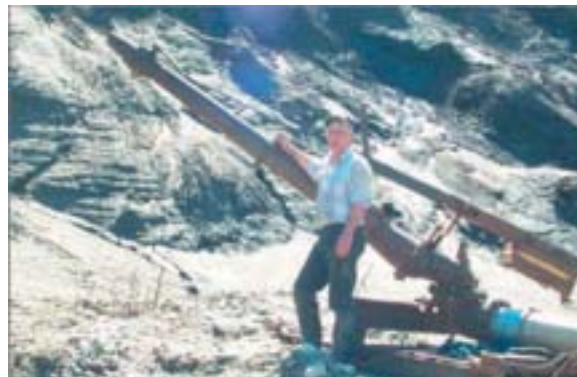
**Title:** Tatlow Placer's monitor on Upper Quartz Creek

In 1991, one Cat D9L dozer with U-blade and ripper was used for stripping and pushing pay gravel into the wash plant. Water monitors were used to strip frozen overburden. A dump box 14 feet wide by 20 feet long washed by a water monitor fed a center sluice run 12 inches wide by 20 feet long, and two side runs 4 feet wide and 20 feet long. Up to 180 loose yards per hour were processed using 6000 igpm of water, supplied by a 10 by 12 inch Morris pump, powered by a Cat 3408 diesel. Water was recycled in old mining cuts on Upper Quartz Creek. Waste settled in large settling ponds in old mining cuts in the Indian River Valley.

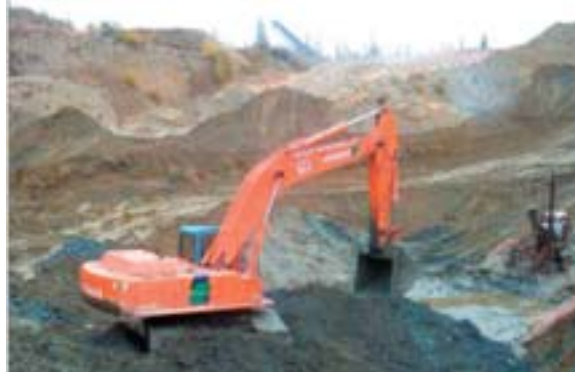
**D-115014-5**

**Title:** Tatlow Placers open pit on Little Blanch Creek
