Yukon Placer Database Operations Report

Field Name: Nichols/Pfisterer, 1988-2003

Stream: Quill: a tributary of Kluane River

Map Sheet(s): 115G/11, 115G/6

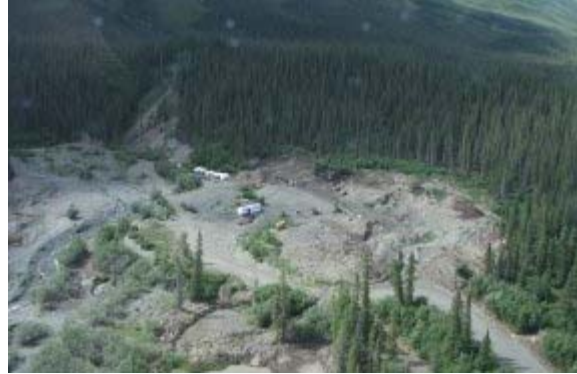
Title: Nichols Operation on Quill Creek; 2003
